# Manhole Inspection Summary

Manhole # S35W\_\_019MH

Insp Date: **2/29/08 11:18 AM**

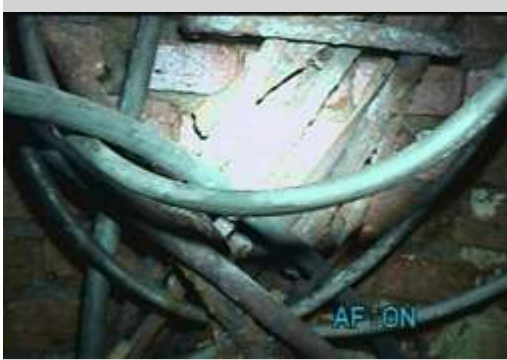
Defect 2

Count: **4** Missing: **0** ☒ **Corroded**

steps

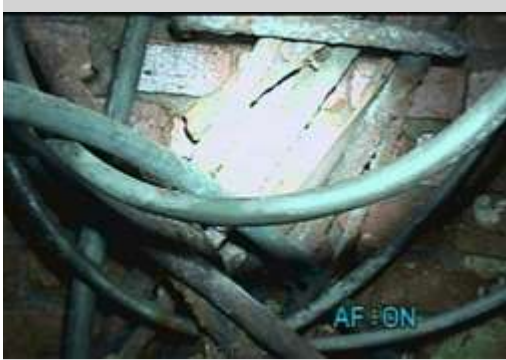
Defect 1

debris

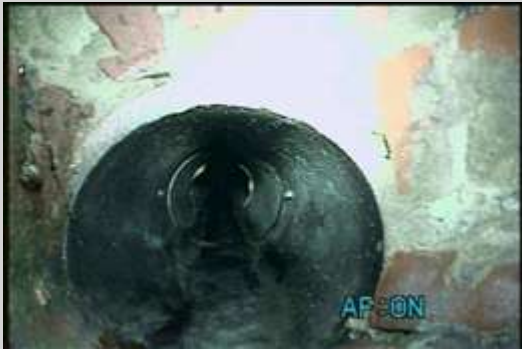
12 O'Clock Outflow

8 in. Circular Gravity Sewer  
Pipe Out @ 12 O'Clock

Pipe Material: **Clay** ☐ Pipe Lined

Invert Depth: **10.00** (ft.) Flow Characteristics: **Fast**

Deposits: ☒ None ☐ Mud ☐ Sludge ☐ Debris ☐ Grease

Infiltration: **None** Pipe Seal Cond: **Unknown**

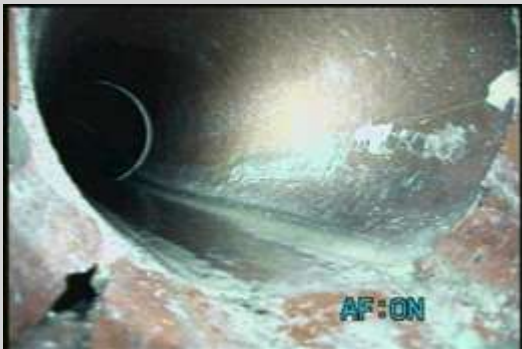
3 O'Clock Inflow

8 in. Circular Gravity Sewer  
Pipe In @ 3 O'Clock

Pipe Material: **Clay** ☐ Pipe Lined

Invert Depth: **9.70** (ft.) Flow Characteristics: **Fast**

Deposits: ☒ None ☐ Mud ☐ Sludge ☐ Debris ☐ Grease

Infiltration: **None** Pipe Seal Cond: **Unknown**

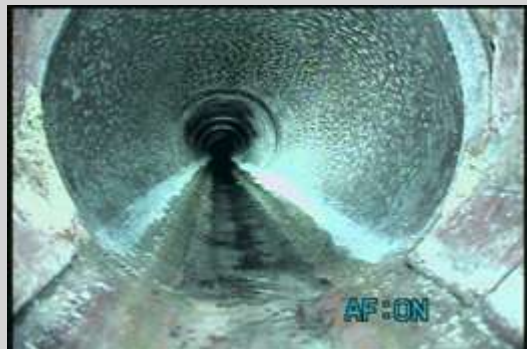
6 O'Clock Inflow

8 in. Circular Gravity Sewer  
Pipe In @ 6 O'Clock

Pipe Material: **Clay** ☐ Pipe Lined

Invert Depth: **9.60** (ft.) Flow Characteristics: **Fast**

Deposits: ☒ None ☐ Mud ☐ Sludge ☐ Debris ☐ Grease

Infiltration: **None** Pipe Seal Cond: **Unknown**
